## Universal rules for checking the car body

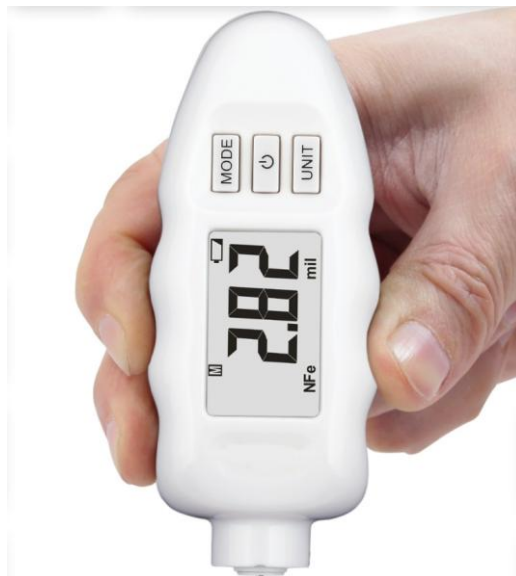
**The paintwork thickness on repainted parts is 2-4 mil thicker on average. In the case of painting under the thickness gauge, the paintwork thickness will remain close to factory values (if there is no putty).**

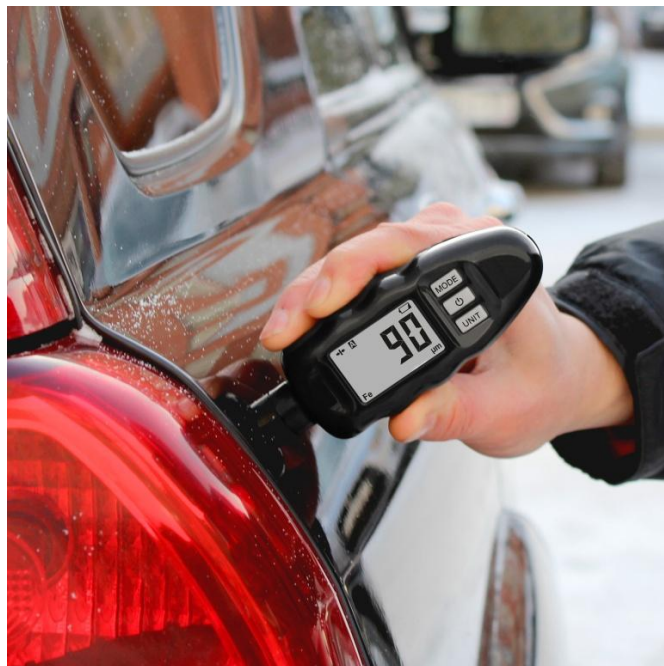
**All cars are evenly painted. Pronounced deviations in paintwork thickness among different doors most likely indicate repainted parts.**

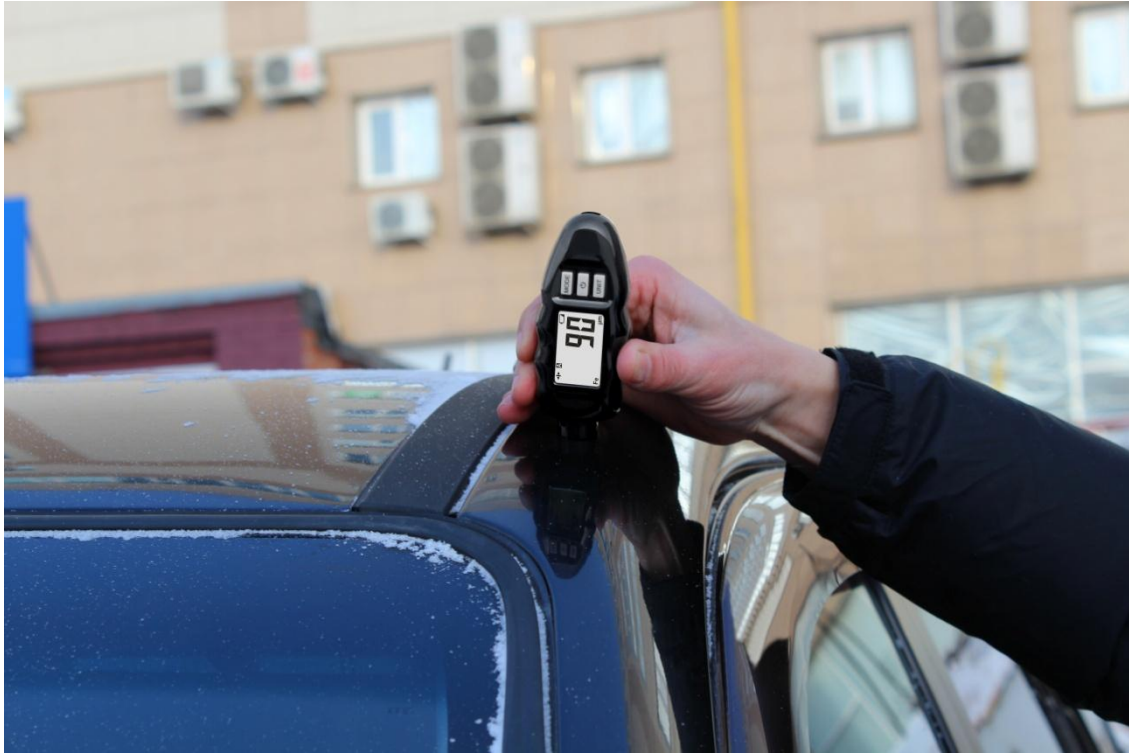
**The roof racks should be checked in small increments (every 2 inches) so as not to miss the putty on welds.**
